## MOLD & MOISTURE INSPECTION REPORT

*Sample Report - Limited Assessment of Basement, First Floor and Primary Bedroom*

| <b>Report Number</b> | 26049821 | <b>Report Date</b> | August 11, 2026 |
| <b>Property</b> | 1234 Maple Hill Lane<br>Anytown, PA 17315 | <b>Client Email</b> | janyname@mail.com |

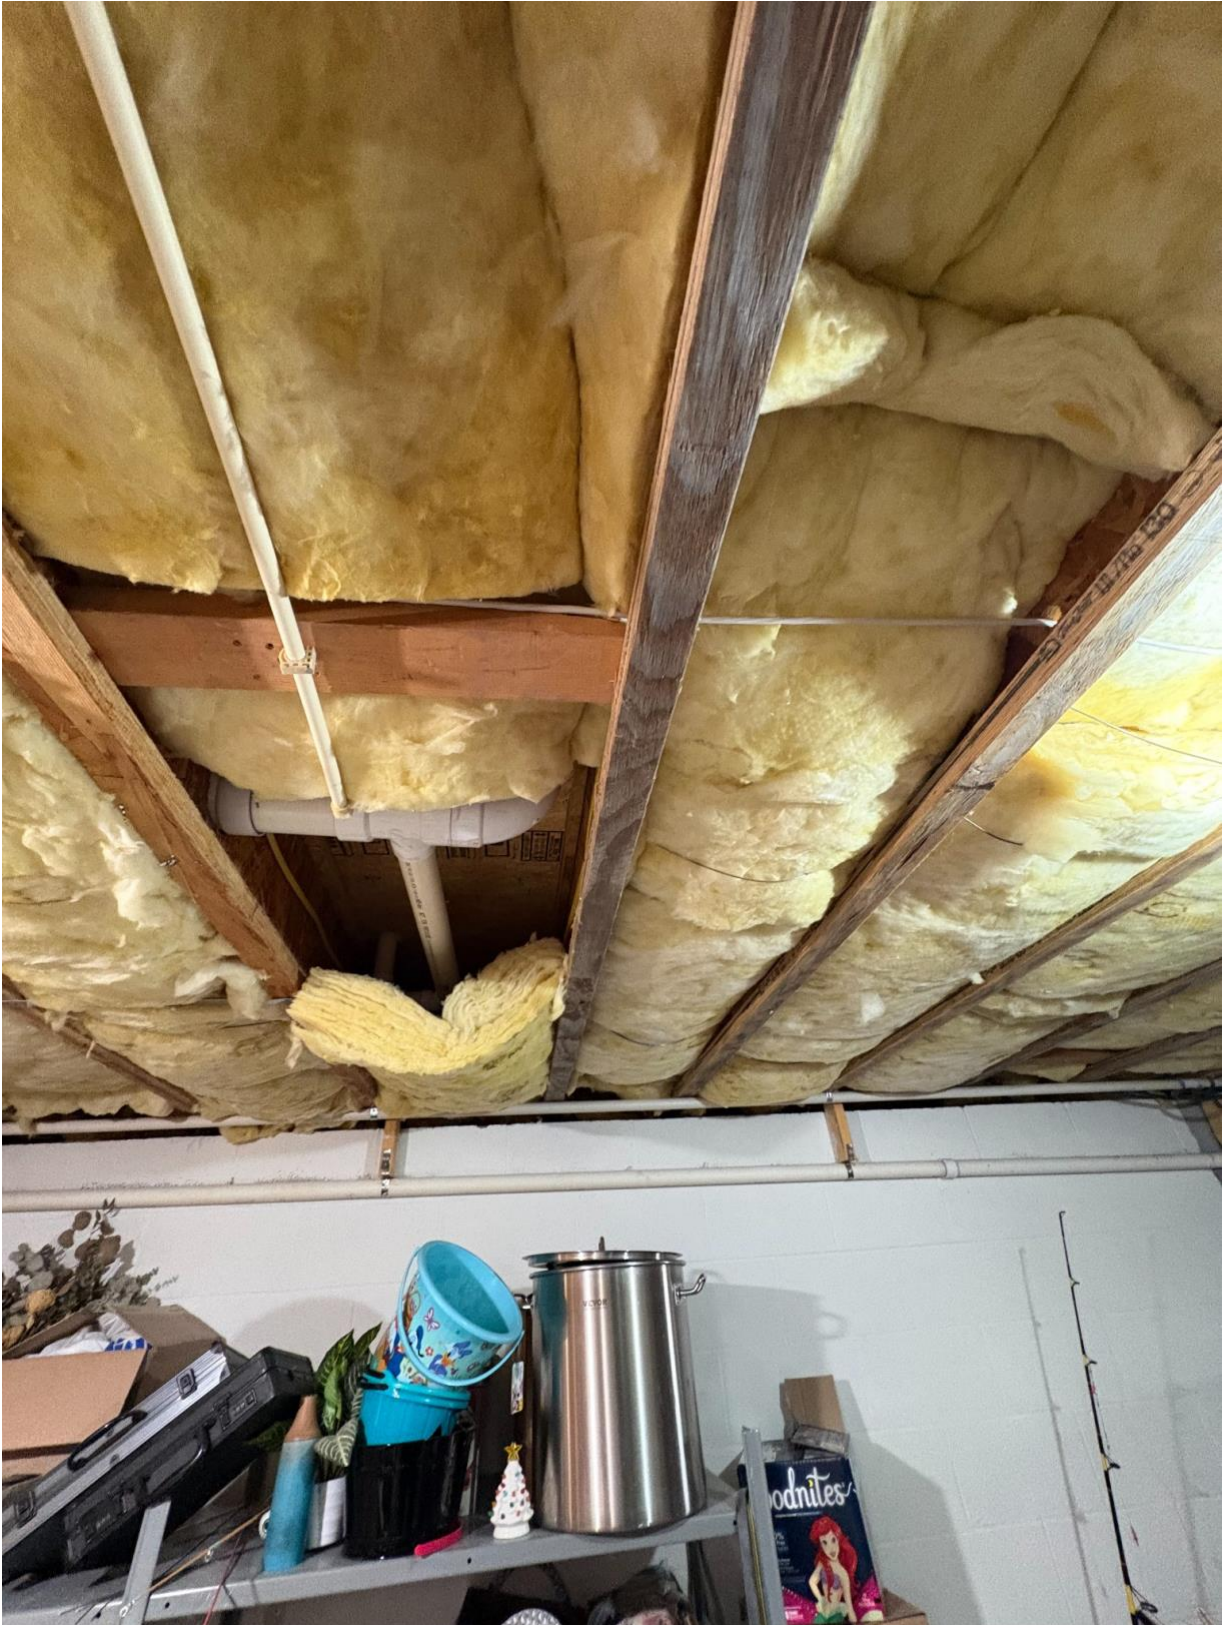
Visible mold-like growth was observed on the underside and sides of multiple floor joists and on portions of the exposed subflooring in the rear unfinished basement. The visible condition was most concentrated in the rear half of the basement beneath the first floor living/kitchen side of the home and was estimated to affect approximately 300 to 450 square feet of overhead framing surfaces. Both tape-lift samples collected from representative joist/subfloor surfaces confirmed fungal growth and mycelium.

*Photo 1 - Example overview of basement floor-joist bottoms and fiberglass insulation in the unfinished basement.*

- Have a qualified mold-remediation contractor remediate the affected unfinished basement framing/subfloor surfaces using proper containment, HEPA filtration, worker protection and dust-control practices.
- Remove or temporarily detach insulation within the remediation work area as needed to access affected joists and subflooring. Discard insulation that is mold-contaminated, damaged or cannot be effectively cleaned.
- HEPA vacuum, clean and detail affected joists, subflooring and adjacent structural surfaces. Re-HEPA vacuum after cleaning to remove residual particulate. Additional cleaning methods may be required if staining/growth remains after standard cleaning.
- Inspect newly exposed wood framing after insulation and obstructions are removed. Expand the work area only if additional affected materials are uncovered during remediation.

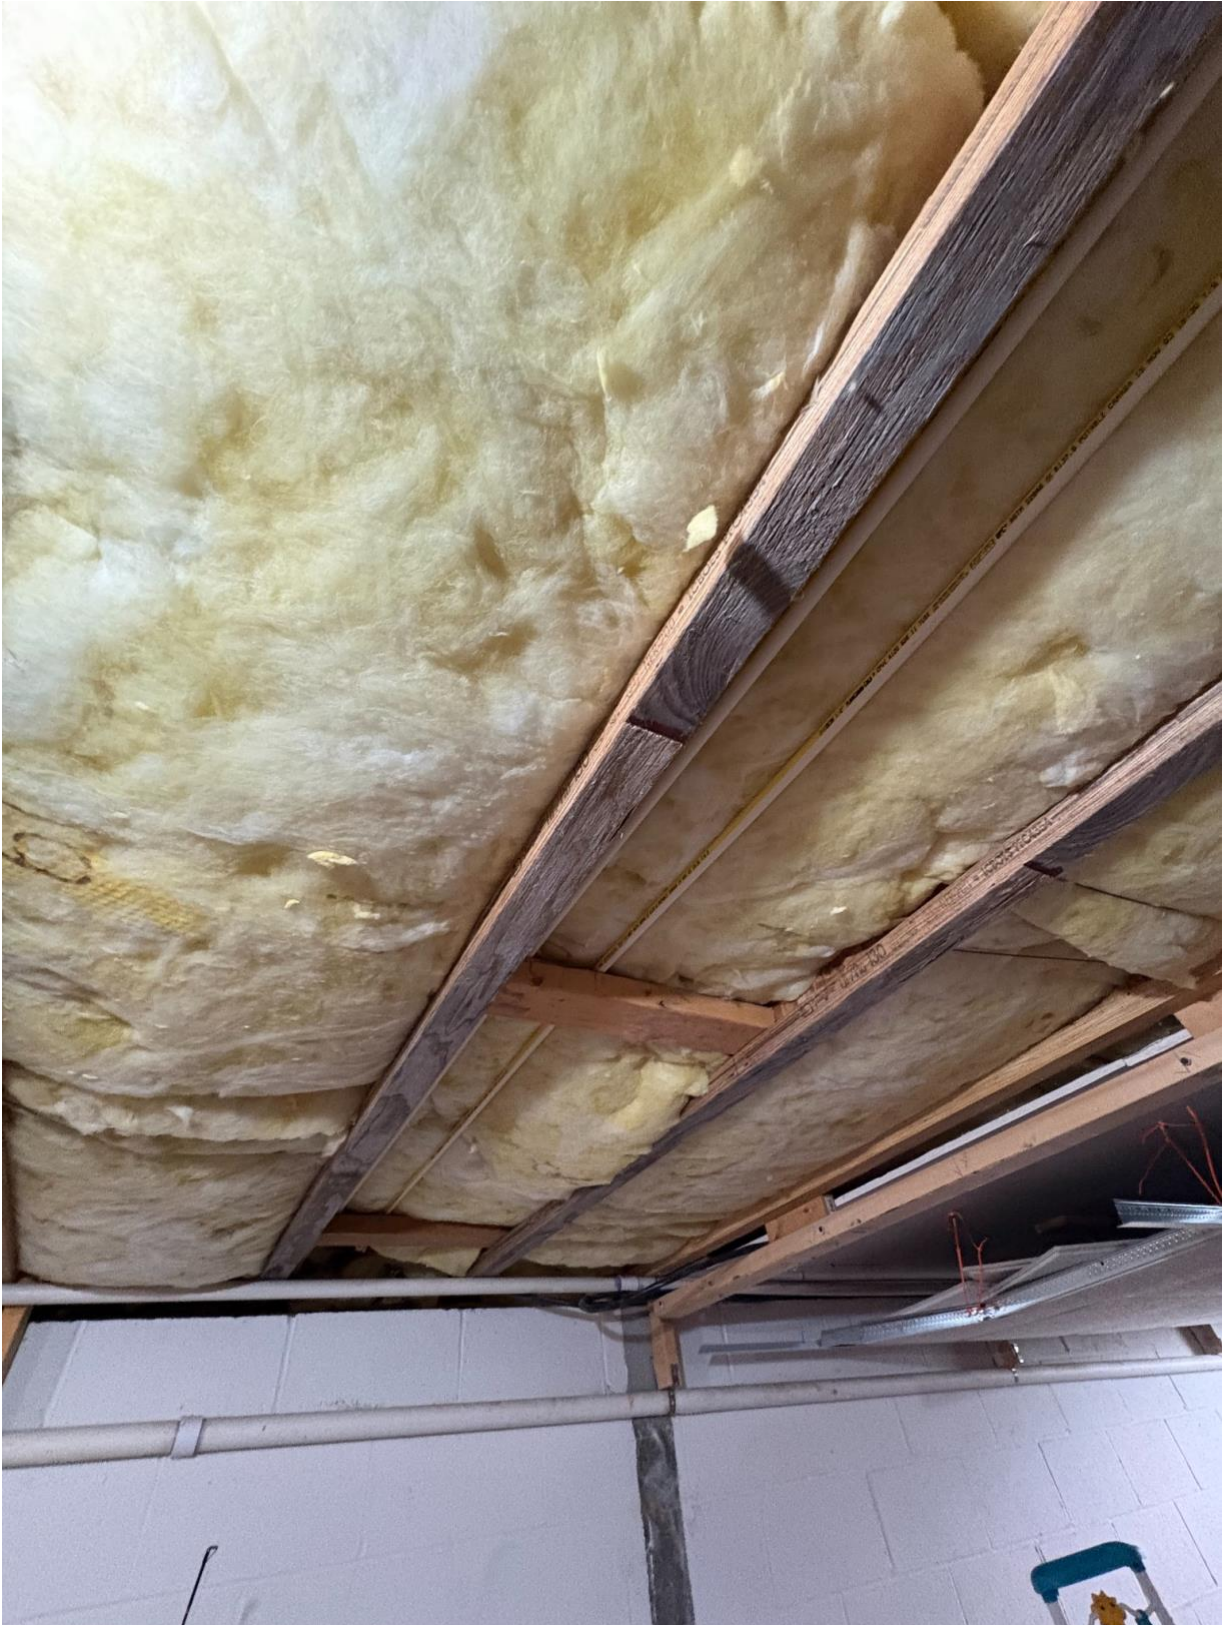
| Sample | Type | Location | Laboratory Result |
|---|---|---|---|
| #5 / Tape Lift 1 | Surface tape | Rear basement floor joist | Aspergillus/Penicillium-like growth: Moderate; Cladosporium: Few; mycelium present. <b>Surface mold confirmed.</b> |
| #6 / Tape Lift 2 | Surface tape | Basement subfloor/joist bay | Cladosporium: Numerous; Aspergillus/Penicillium-like growth: Moderate; mycelium present. <b>Surface mold confirmed.</b> |

*Photo 2 - Example closer view of darker/chalky surface condition along accessible basement joist bottoms.*
